6986 PanoVu Camera Firmware

Version: V5.4.5

Release Note (External) (2017-02-24)

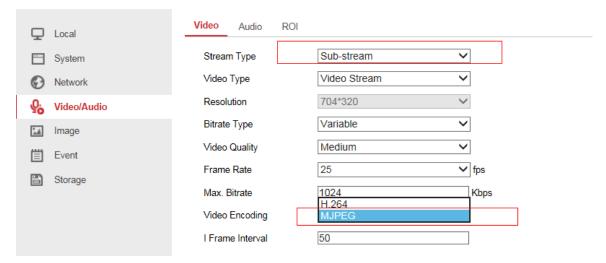
- 1. New Features
- Newly support ONVIF protocol.
- 2. Optimization
- Newly added the MJPEG format of video encoding for Sub Stream.

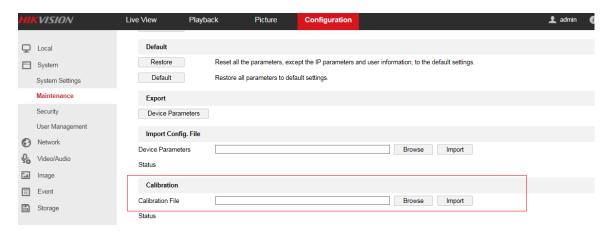
- Modify the default bitrate to 16384Kbps.
- The default resolution of main stream is 12MP (4096*1800).
- Remove the Calibration file import interface.

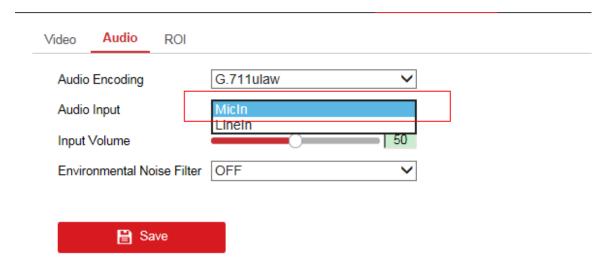
- Solve the issue that it shows Device error when restoring the camera.
- Remove the IP Server and HiDDNS in the web interface.
- 3. Leftover issues
- It keeps the Mic In option in the web interface. Actually the device doesn't support Mic In and it will be removed in the next version.
