## **AX PRO**

# Version: V1.2.9

**Release Note**

## (2024-04-15)

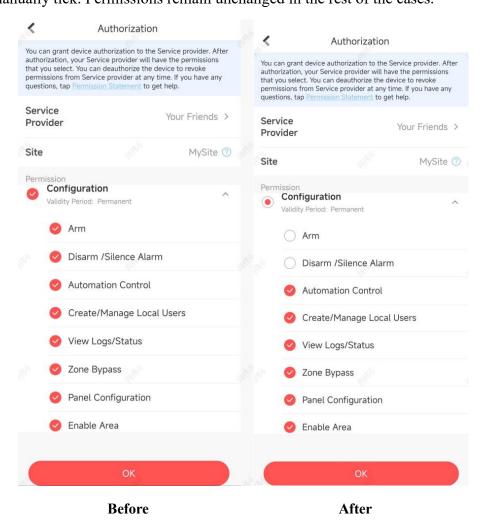
- 2.2 Fix the problem of non-compliance of PD6662 standard function.
- 2.3 Support the following devices DS-PT1-WE/WB)(B), DS-PDMCK-EG2-WE/WB(B), DS-PR1-WE/WB(B) access.
- 2.4 Support HIK IoT card.
- 2.5 HPP sharing function optimization.

Modify authorization permissions, default arm and disarm/Silence alarm

permissions aren't granted to HPP (installer), but still support HC (end user) to manually tick. Permissions remain unchanged in the rest of the cases.

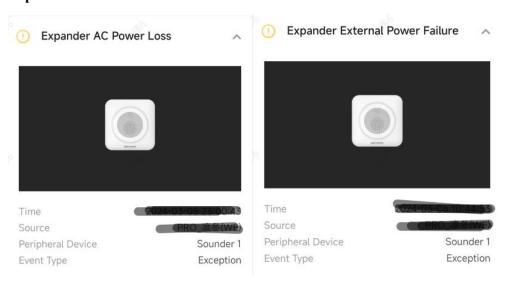
2.6 Sounder& transmitter's original AC Power Loss notification modified to Expander External Power Failure.

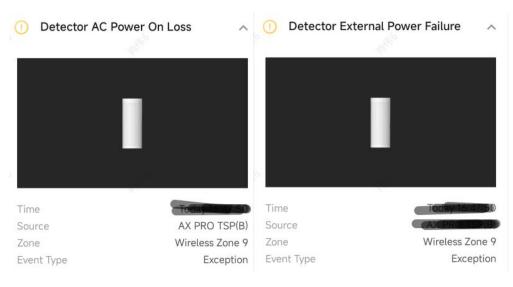
Detector's original AC Power Loss notification modified to Detector External Power Failure.
