TEST REPORT

Equipment under Test: NETWORK CAMERA

Model Number: DS-2XM6522G0-ID

Manufacturer: Hangzhou Hikvision Digital Technology Co., Ltd.

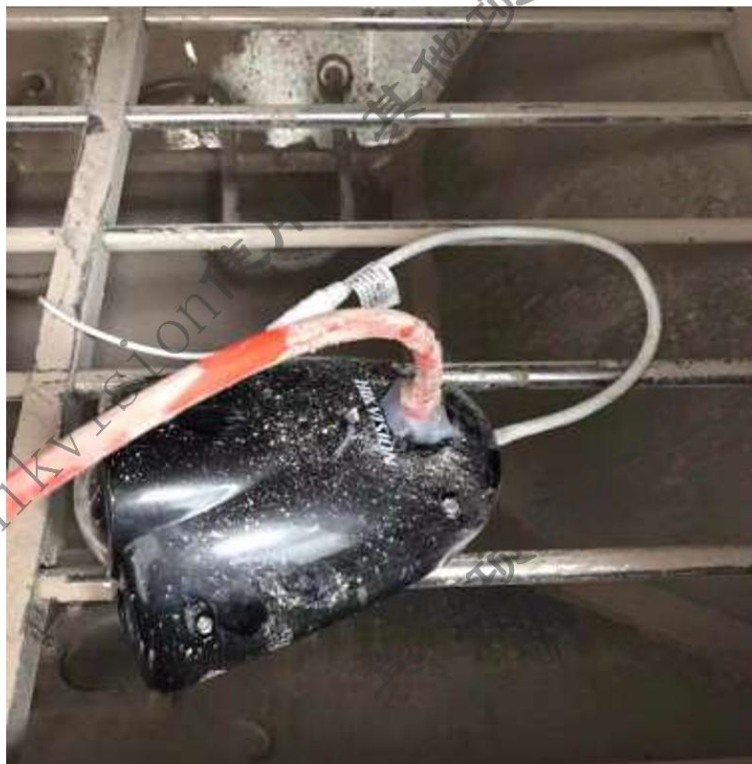
Test picture

Test Items	Technical specifications	Result
		1#
IP6X	<p>Dust-tight, No ingress of dust.</p> <p>The test is performed using a dust chamber. The talcum powder used shall be able to pass through a square-meshed sieve the nominal wire diameter of which is 50 μm and the nominal width of a gap between wires 75 μm. The amount of talcum powder to be used is 2 kg per cubic metre of the test chamber volume.</p> <p>Duration of test: 8 hours.</p> <p>After the test, the inside of EUT should be no dust.</p>	Pass
IPX9K	<p>Test for second characteristic numeral 9 by high pressure and temperature water jetting.</p> <ul style="list-style-type: none"> - Turntable speed: (5 ± 1) r/min - Spray positions: 0°, 30°, 60°, 90° - Distance between nozzle and sample: (100-150)mm - Water flow rate: 15L/min - Water pressure: 10000KPa - Water temperature: $(80 \pm 5)^\circ\text{C}$ - Duration: 30s per position 	Pass
Remark

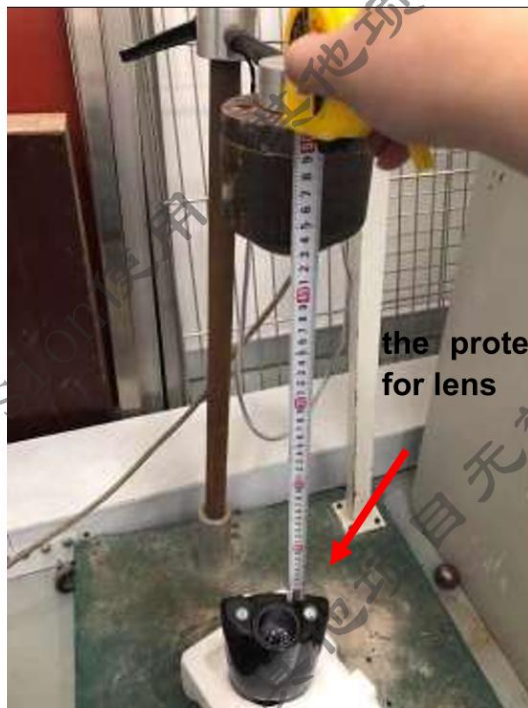
Test picture

Test Items	Technical specifications	Result
		1#
IK10	<p>Impact hammer weight : 5kg(Equivalent to 20J impact energy)</p> <p>Test height: 400mm</p> <p>Number of tests : 3</p> <p>Test mode: free fall</p> <p>Test position: the protective cover for lens</p> <p>After the test, the structure should be no damage.</p>	Pass
Remark

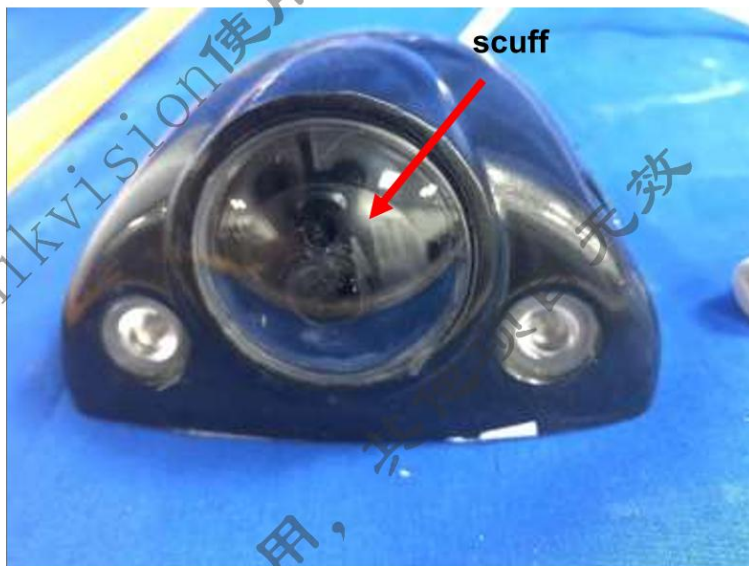
After the test
