TEST REPORT

Equipment under Test: Vehicle Camera

Model Number: AE-VC122T-ITSX

**National Computer Peripheral Equipment Quality
Supervising Test Center**

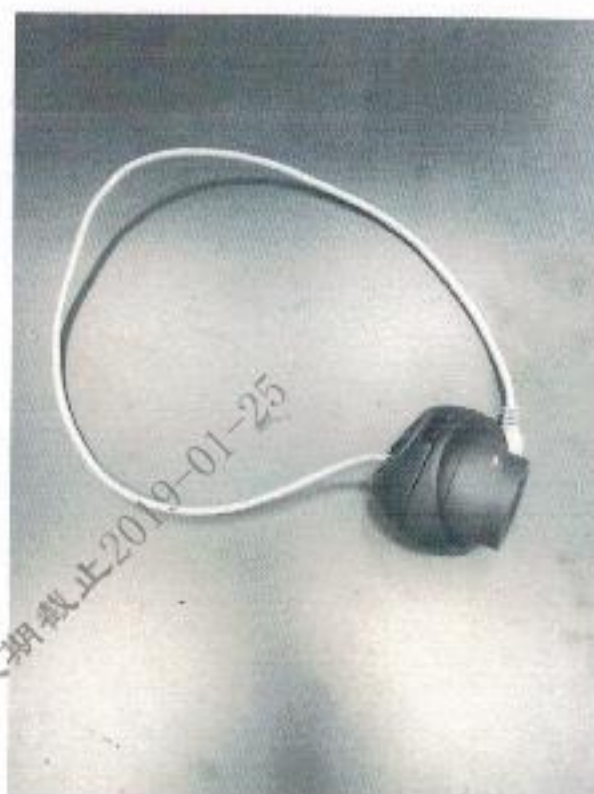
After the test

The sample is intact

Test Items	Technical specifications	Result
		1#
IK08 hammer test	<p>Impact hammer weight : 1.7kg (Equivalent to 5J impact energy)</p> <p>Test height: 300mm</p> <p>Number of tests : 3</p> <p>Test mode: free fall</p> <p>Test position: the protective cover for lens</p> <p>After the test, there is no damage on the structure, and all functions of the equipment remain normal.</p>	Pass
Remark	Test pictures please refer to the following pages.
