Equipment under Test: Network camera

Model Number: DS-2XM6425G0/F-L32

Test Report

No:2019-1048

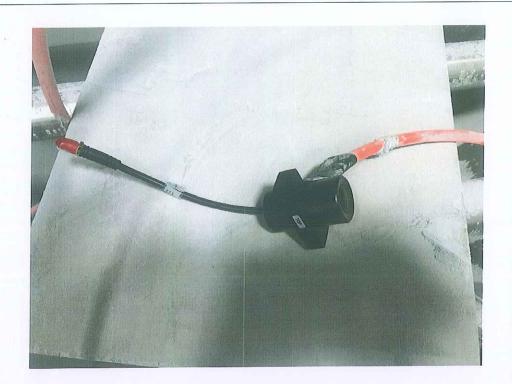
During the test (IP6X)

Test Items	Technical specifications	
rest iteme		
IP6X	Dust-tight, No ingress of dust. The test is performed using a dust chamber. The talcum powder used shall be able to pass through a square-meshed sieve the nominal wire diameter of which is 50 µm and the nominal width of a gap between wires 75 µm. The amount of talcum powder to be used is 2 kg per cubic metre of the test chamber volume. Duration of test: 8 hours. After the test, the inside of EUT should be no dust.	
IPX7	Diving tests for a short time, No ingress of water. -The test is made using a water tank. -Temperature of the water tank: 20°C -Samples from the bottom of the water: 1000mm -Duration of test: 30 minutes After test, the inside of EUT should be no water.	Pass
Remark

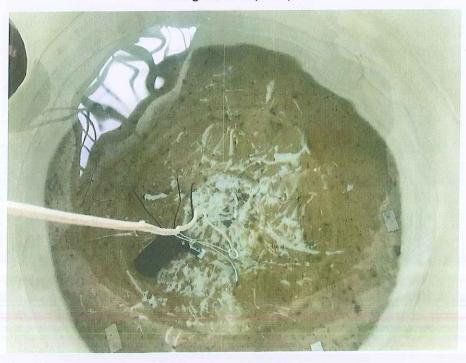
During the test (IPX7)
