TEST REPORT

Equipment under Test: NETWORK CAMERA

Model Number: DS-2XM6222FWD-IM

Manufacturer: Hangzhou Hikvision Digital Technology Co., Ltd.

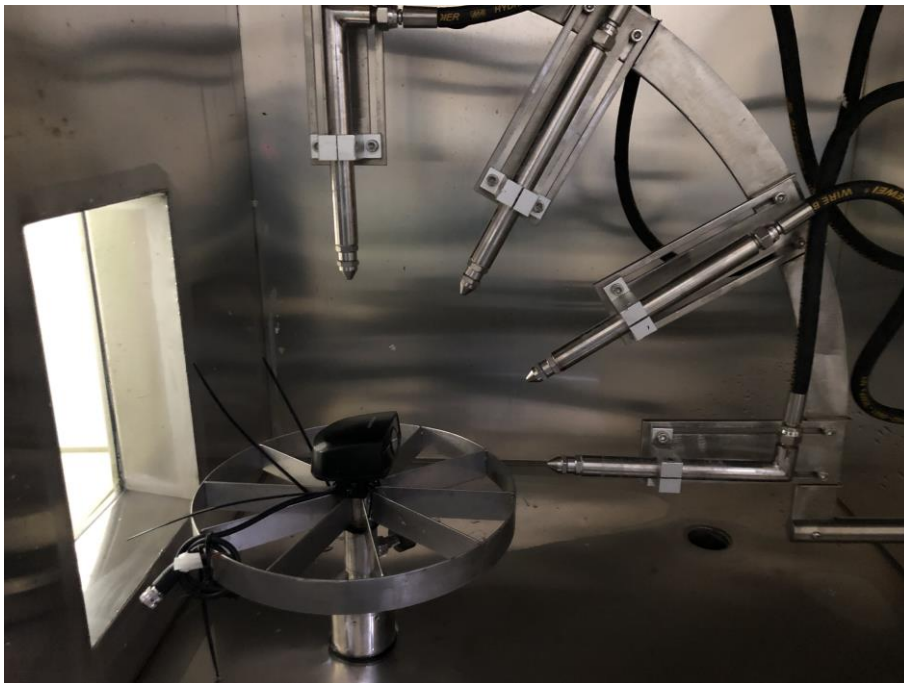
Test picture

IPX9

Test Items	Technical specifications	Result
		1#
IPX9	<p>Test for second characteristic numeral 9 by high pressure and temperature water jetting.</p> <ul style="list-style-type: none"> - Water temperature: $(80 \pm 5)^{\circ}\text{C}$ - Turntable speed: (5 ± 1) r/min - Distance between nozzle and sample: (100-150)mm - Water flow rate: 15L/min - Water pressure: 10000KPa - Spray positions: 0° , 30° , 60° , 90° - Duration: 30s per position <p>After the test, the inside of EUT should be no water.</p>	Pass
Remark
