TEST REPORT

Equipment under Test: NETWORK CAMERA

Model Number: DS-2XM6522G0-ID

Manufacturer: Hangzhou Hikvision Digital Technology Co., Ltd.

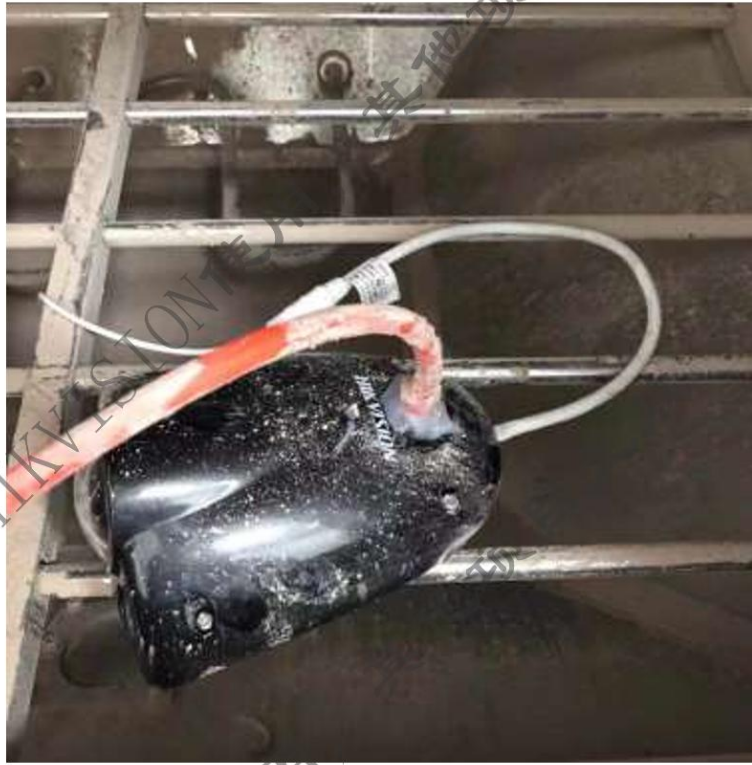
Test Items	Technical specifications	Result
		1#
IP6X	<p>Dust-tight, No ingress of dust.</p> <p>The test is performed using a dust chamber. The talcum powder used shall be able to pass through a square-meshed sieve the nominal wire diameter of which is 50 μm and the nominal width of a gap between wires 75 μm. The amount of talcum powder to be used is 2 kg per cubic metre of the test chamber volume.</p> <p>Duration of test: 8 hours.</p> <p>After the test, the inside of EUT should be no dust.</p>	Pass
IPX9K	<p>Test for second characteristic numeral 9 by high pressure and temperature water jetting.</p> <ul style="list-style-type: none"> - Turntable speed: (5 ± 1) r/min - Spray positions: 0°, 30°, 60°, 90° - Distance between nozzle and sample: (100-150)mm - Water flow rate: 15L/min - Water pressure: 10000KPa - Water temperature: $(80 \pm 5)^\circ\text{C}$ - Duration: 30s per position 	Pass
Remark

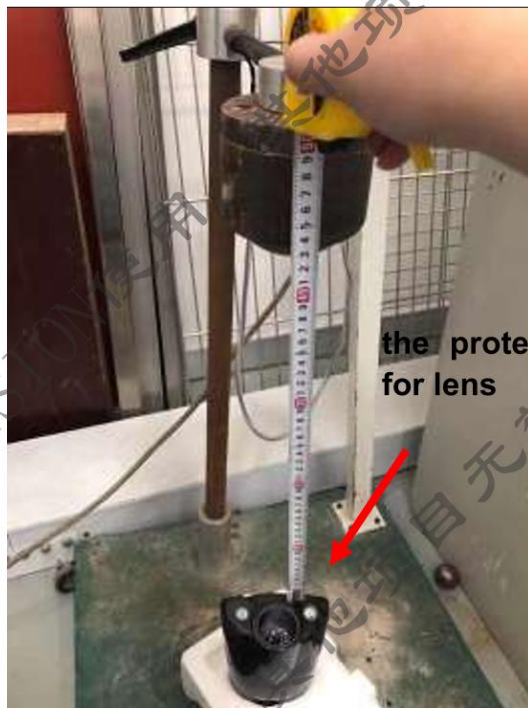
Test Items	Technical specifications	Result
		1#
IK10	<p>Impact hammer weight : 5kg(Equivalent to 20J impact energy)</p> <p>Test height: 400mm</p> <p>Number of tests : 3</p> <p>Test mode: free fall</p> <p>Test position: the protective cover for lens</p> <p>After the test, the structure should be no damage.</p>	Pass
Remark

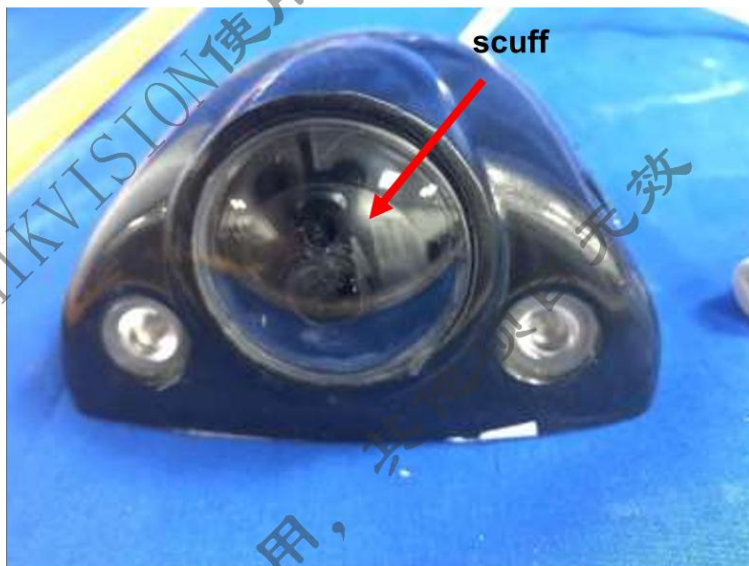
After the test
