TEST REPORT

Equipment under Test: NETWORK CAMERA

Model Number: DS-2XM6522G0-ID

Test Report

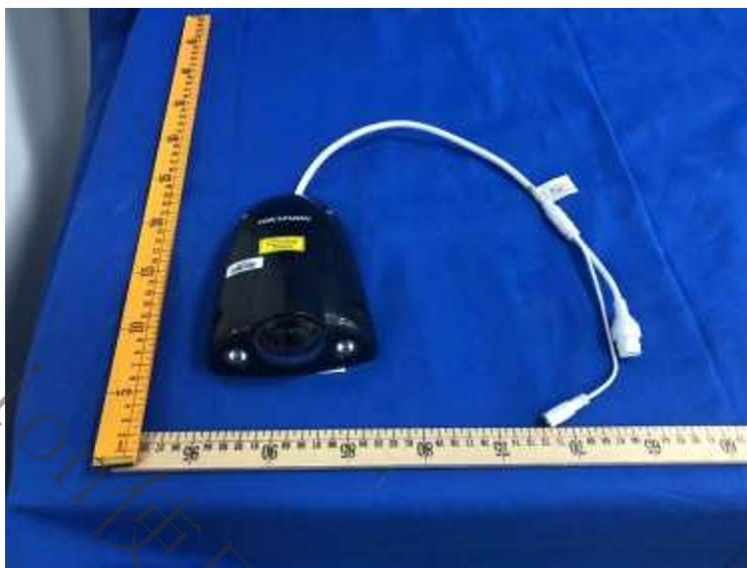
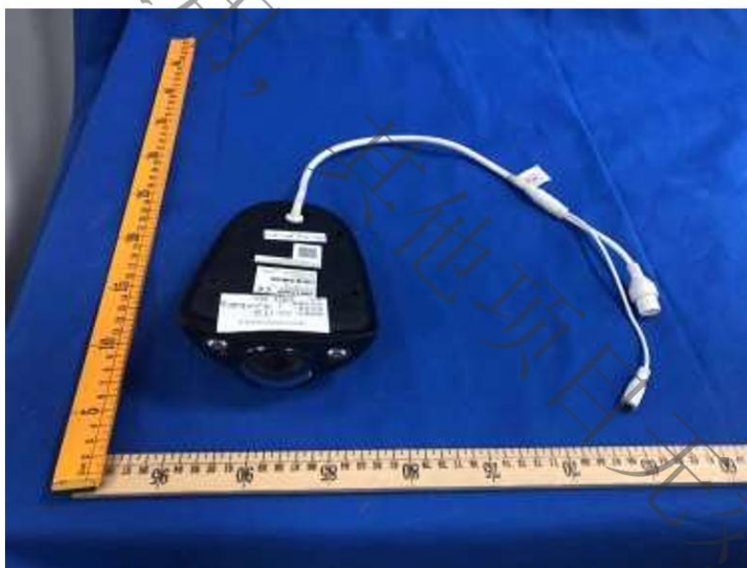
EUT picture

HIKVISION **CE**
IR NETWORK CAMERA
Model: DS-2XM6522G0-ID 2.8mm
I/P: 24V \equiv TBDA, TBDW

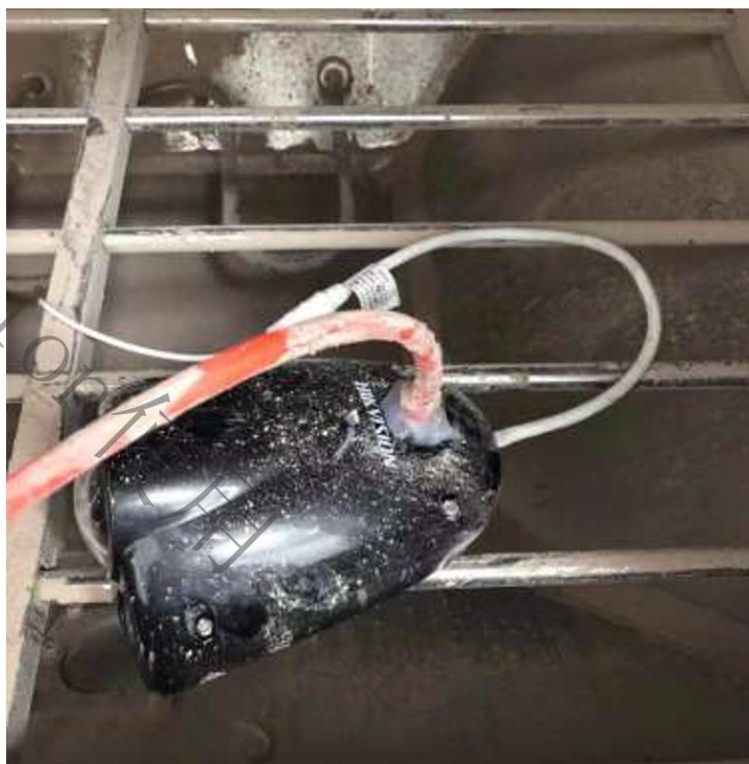
Test Items	Technical specifications	Result
		1#
IP6X	<p>Dust-tight, No ingress of dust.</p> <p>The test is performed using a dust chamber. The talcum powder used shall be able to pass through a square-meshed sieve the nominal wire diameter of which is 50 μm and the nominal width of a gap between wires 75 μm. The amount of talcum powder to be used is 2 kg per cubic metre of the test chamber volume.</p> <p>Duration of test: 8 hours.</p> <p>After the test, the inside of EUT should be no dust.</p>	Pass
IPX9K	<p>Test for second characteristic numeral 9 by high pressure and temperature water jetting.</p> <ul style="list-style-type: none"> - Turntable speed: (5 ± 1) r/min - Spray positions: 0° , 30° , 60° , 90° - Distance between nozzle and sample: (100-150)mm - Water flow rate: 15L/min - Water pressure: 10000KPa - Water temperature: $(80 \pm 5)^\circ\text{C}$ - Duration: 30s per position 	Pass
Remark

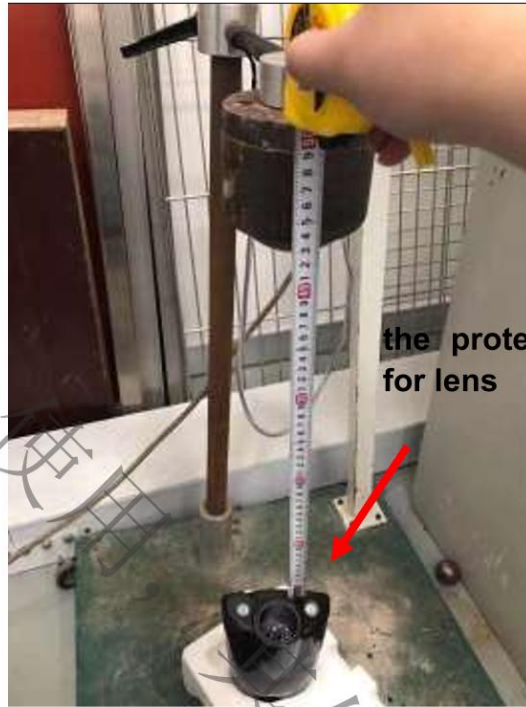
Test Items	Technical specifications	Result
		1#
IK10	<p>Impact hammer weight : 5kg(Equivalent to 20J impact energy)</p> <p>Test height: 400mm</p> <p>Number of tests : 3</p> <p>Test mode: free fall</p> <p>Test position: the protective cover for lens</p> <p>After the test, the structure should be no damage.</p>	Pass
Remark

the protective cover
for lens

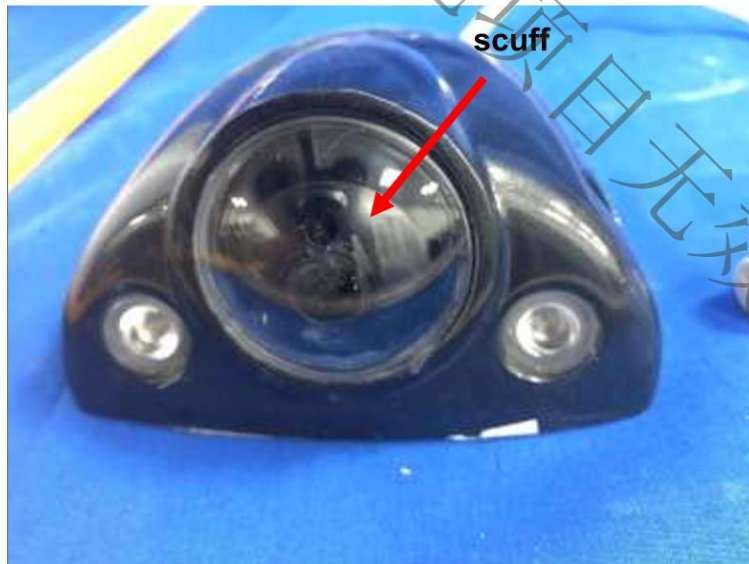
After the test

scuff
